# Eternal Witnesses—Documentation and Analysis of Carved Historic Graffiti and Inscriptions on Stone Surfaces

## Abstract

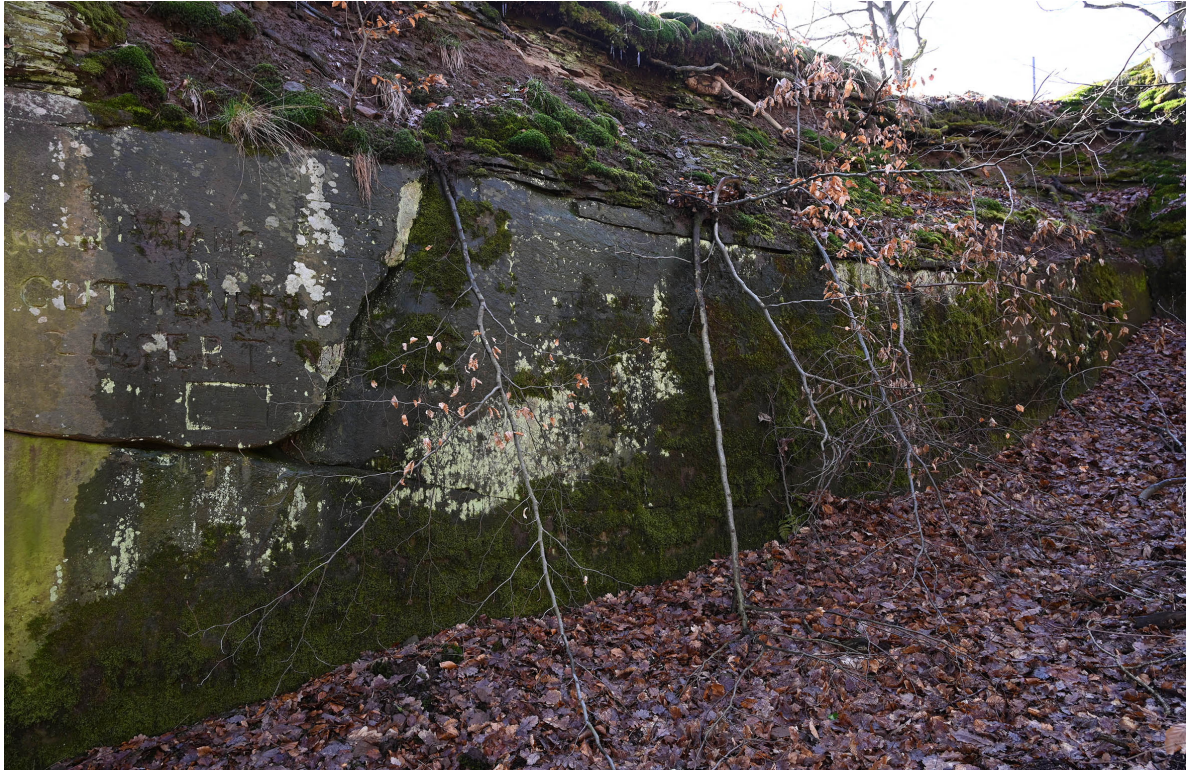
**Figure 2.** Section of the sandstone wall, highlighting the issues of biological growth.

There are many challenges at the site; the quarry is gradually disappearing into the surrounding wood, and the characters are being erased by ongoing deterioration due to moisture and biological coatings (Figure 2). Therefore, the site was recorded with a multilevel documentation approach using a combination of terrestrial laser scanning (TLS) and high-resolution structured light scanning (SLS). This approach will help preserve this remarkable location, along with its 300 years of graffiti and inscriptions in at least a digital form (Tenschert et al., 2023).

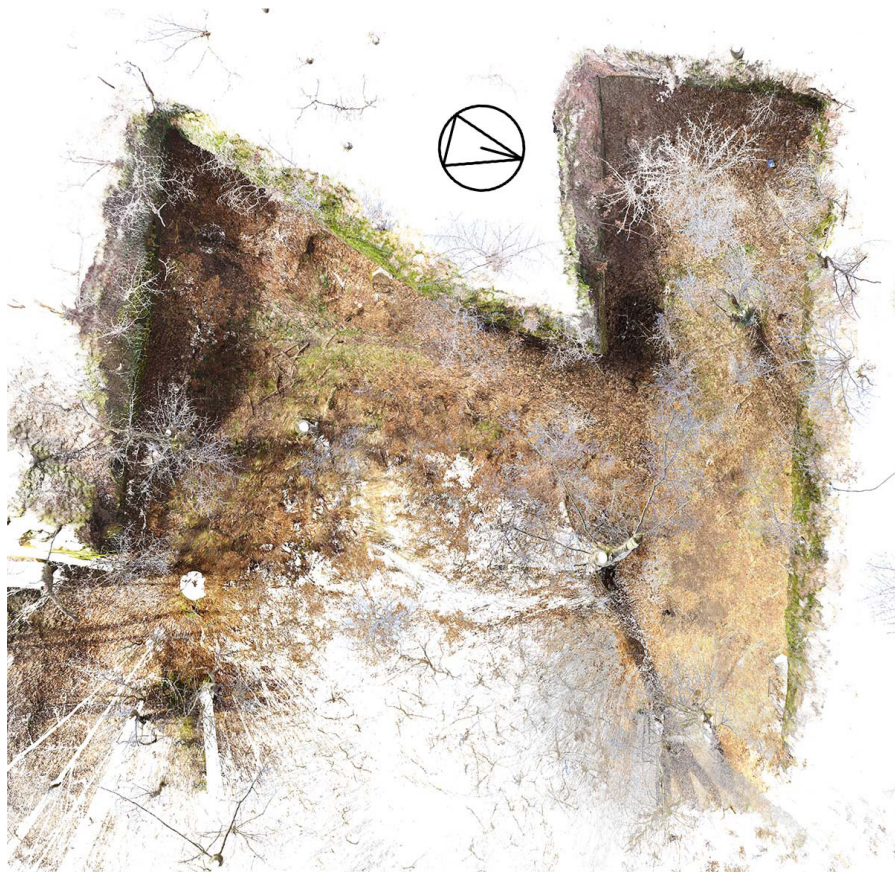
**Figure 4.** Point cloud overview of the 1225 m<sup>2</sup> area of the abandoned quarry; the point cloud could serve as a basis for a ground floor plan and as a general 3D documentation.

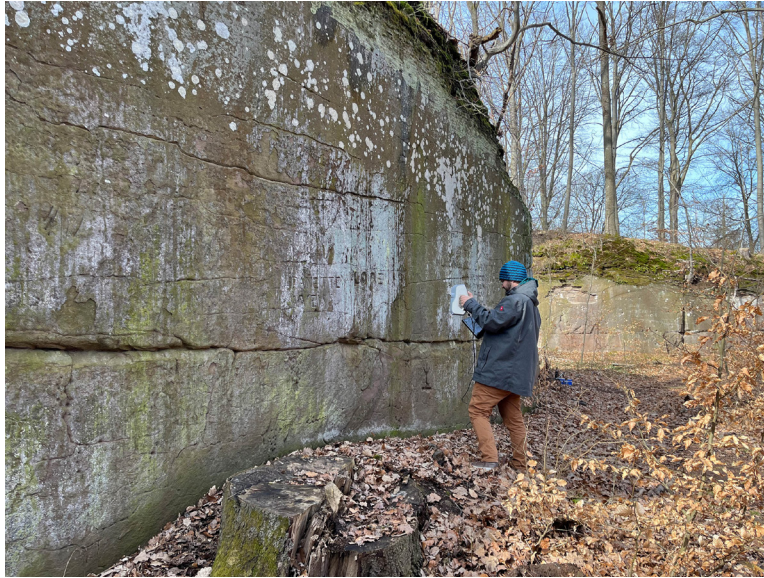
**Figure 5.** Conducting the 3D scan in the Fingalshöhle with the Artec EVA.

2023). An Artec EVA scanning device with Artec Studio 15 software was used to carry out the high-resolution scanning of these more delicate graffiti and inscriptions (Figure 5). The settings ensure a 3D point distance of up to 0.2 mm, though depending on the surface, a point distance of 0.5 mm to 1.0 mm was more likely (Artec3D, 2020). The device and resolution were chosen for this case study to ensure that the recording can be performed outdoors without a power supply and that even filigree scratchings are properly recorded. The approximately 30 most vulnerable graffiti and

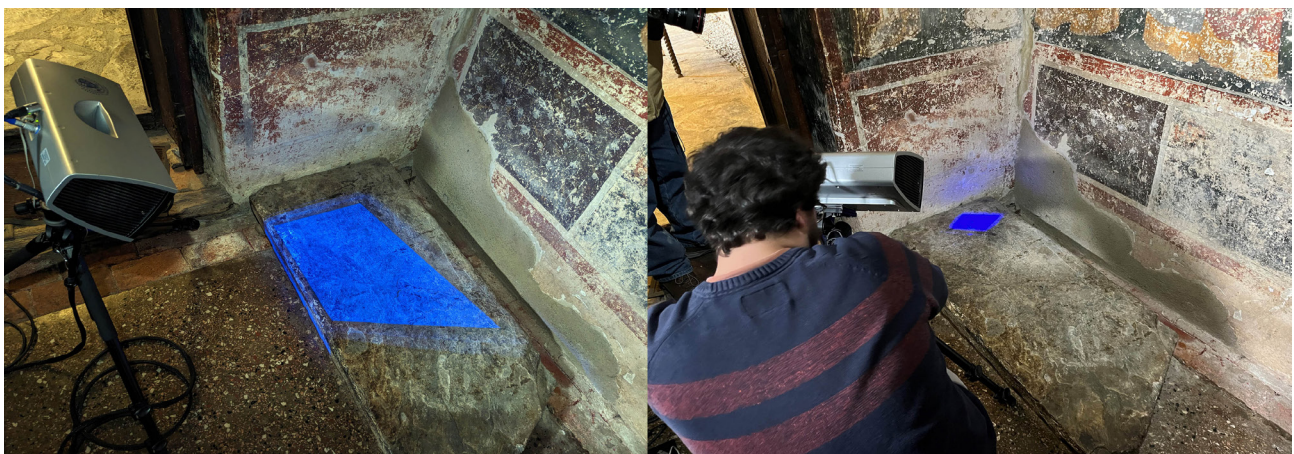
**Figure 6.** Scanning the gravestone of St. Kliment in Ohrid using the Comet L3D 5M with two different resolutions and, therefore, different areas to capture, left: 260 mm x 215 mm at 0.1 mm point spacing, right: 74 mm x 62 mm at 0.03 mm point spacing.

The Comet L3D 5M was used because of its flexibility regarding the resolution; by changing the pair of lenses on the sensor, the measuring field of the scanner can be adapted to the desired surface resolution. The entire gravestone was recorded with the 250 mm lenses, which can record an area of 260 mm x 215 mm (with a depth of field of 140 mm), yielding a mean point spacing of 0.1 mm (Figure 6 left) (Steinbichler Optotechnik GmbH, 2014). In total, the recording consists of 46 individual scans, taken with an overlap of more than 50 %. This part of the gravestone was recorded in higher resolution to ensure that the delicate characters on the top of the stone could be analysed with the highest possible accuracy. These 21 scans were performed with a second set of lenses, ensuring a 3D point distance of 0.03 mm while covering an area of 74 mm x 62 mm (with a depth of field of 45 mm) per single acquisition (Figure 6 right) (Steinbichler Optotechnik GmbH, 2014). It was decided to use a structured light scanner that specialises in highly accurate acquisition of the stones' surface geometry, since the texture information is not needed to analyse the characters further (see also Tenschert et al. (2018)). Without the texture information, the surface structure is more obvious and can be virtually investigated in great detail using raking light generated with artificial light sources. Due to the high-resolution documentation of the surface topography in the sub-millimetre range, surface features of the strokes of the characters can be detected and analysed precisely to ensure a correct transcription.

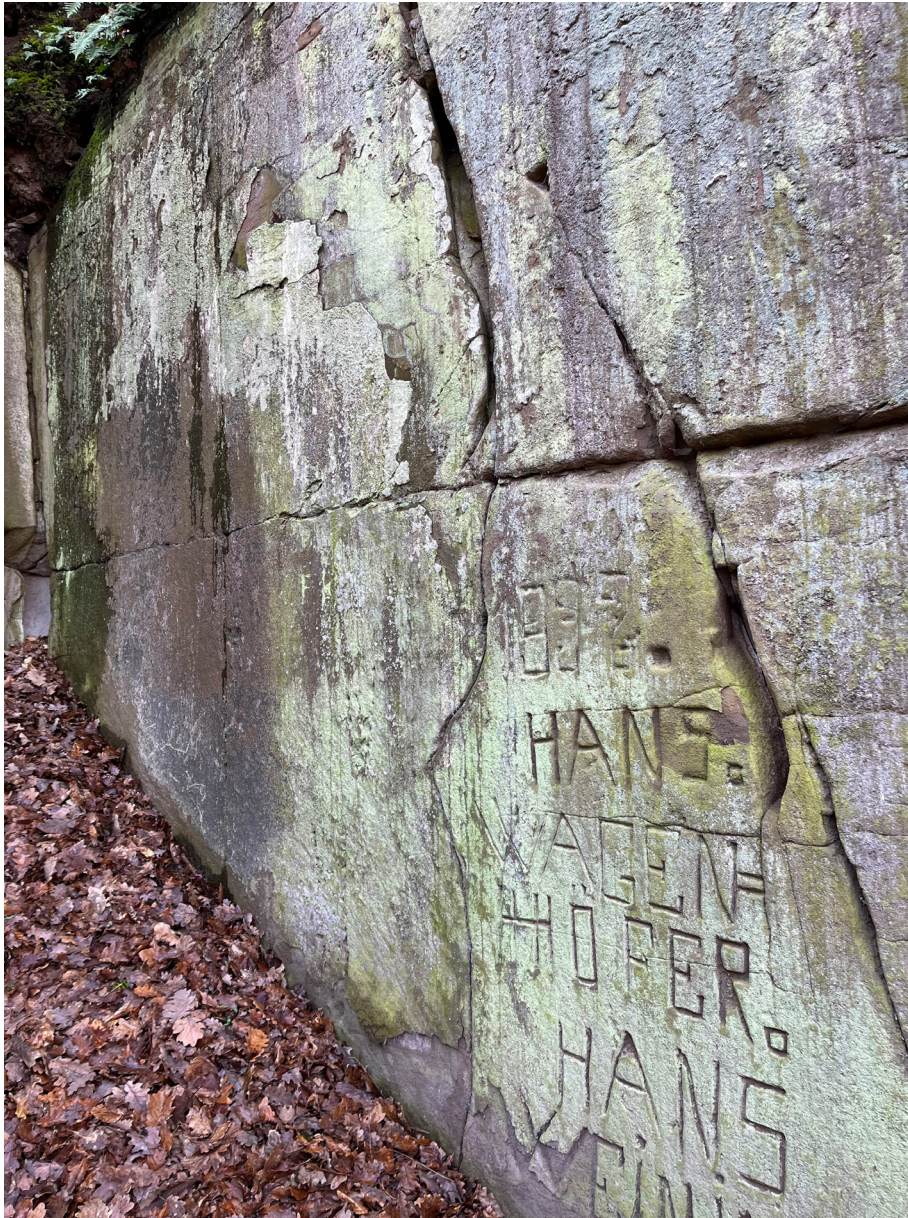
**Figure 7.** Area of the stone walls of the Fingalshöhle showcasing deterioration caused by weathering and the overgrowth with lichens, algae and moss.

deterioration patterns (ICOMOS - International Scientific Committee for Stone [ISCS], 2010), are erosion, mechanical damage and biological colonisation, as well as moist areas due to water drainage (Figures 7 and 8). Because of these ongoing deterioration processes, the graffiti and inscriptions in the former quarry are slowly but steadily being erased.

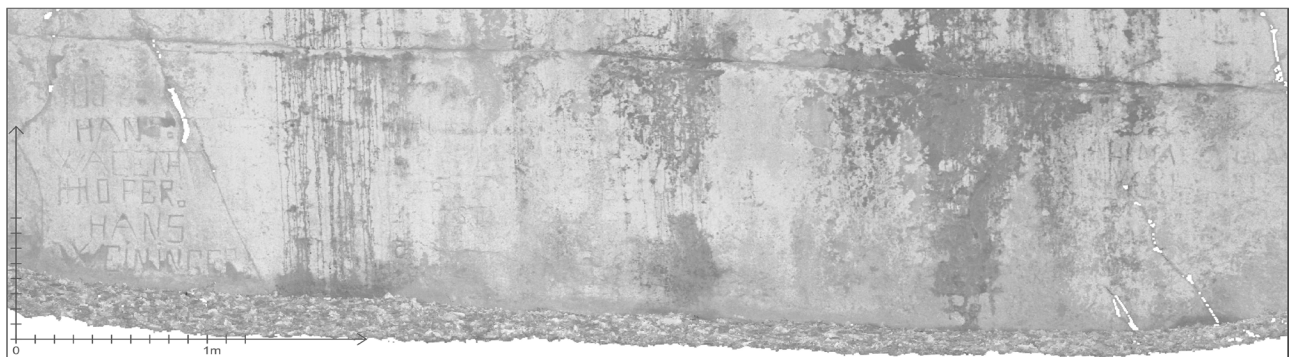
**Figure 9.** Orthophoto of an area of the 107 meters of stone walls of the Fingalshöhle, showcasing graffiti readable in the TLS-data (left and right), also visible are the moist areas in darker grey.

and can even be read in the TLS data (Figure 9). Some inscriptions are very well arranged with small sketches or drawings, for example, a group of writings with a military theme that serve as witnesses of the quarry's use as quarters for both German and French troops (also described in Schultheiß, 1986; Tenschert et al., 2023). Some of the graffiti and inscriptions are dated, and some just give a name. There are numerous inscriptions and graffiti, and one can also find traces of installations and many bullet holes in the area of the quarry, illustrating the site's usage and history in times of war. Some inscriptions and graffiti are clearly visible, but many are unreadable either in photographs (with raking light) or with the naked eye. The content of these examples of carved witnesses was only revealed using the high-

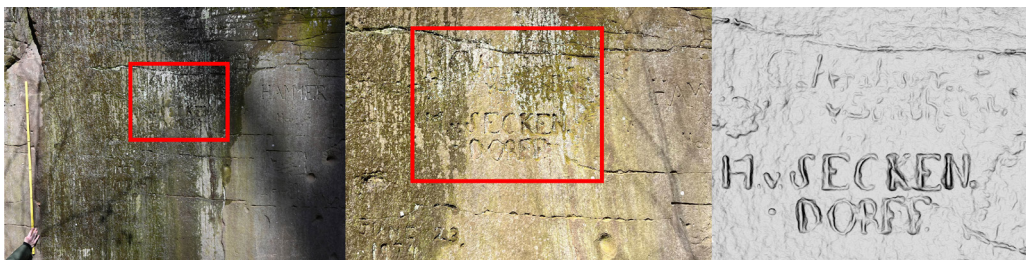
**Figure 11.** Graffiti mentioning "H. v. Seckendorff" and the more delicately carved "G. Krahiser v. Sontheim" above, unreadable in photographs with different lighting and moisture conditions.

An example of a nearly unreadable graffiti is shown in Figure 11: Above a deeply scratched graffiti, mentioning “H. v. Seckendorff”, there is another with more delicately scratched characters mentioning “G. Krahiser v. Sontheim” (Sontheim is a nearby village) (Tenschert et al., 2023). The Seckendorff family is an old noble Franconian family and the

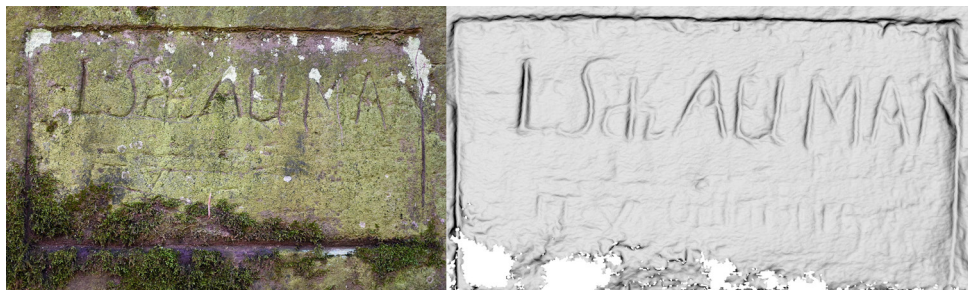
**Figure 13.** Graffiti quoting L. SchaUMAN. Comparison of the barely readable graffiti in a photo and in the orthophoto of the 3D model.

Another example is letters that can be combined to form “L. SchaUMAN”, but both moss and lichen combine to make the lower area barely legible (Figure 13). In the 3D surface model, however, further letters can be recognised, which could indicate the name of a place or of another person.

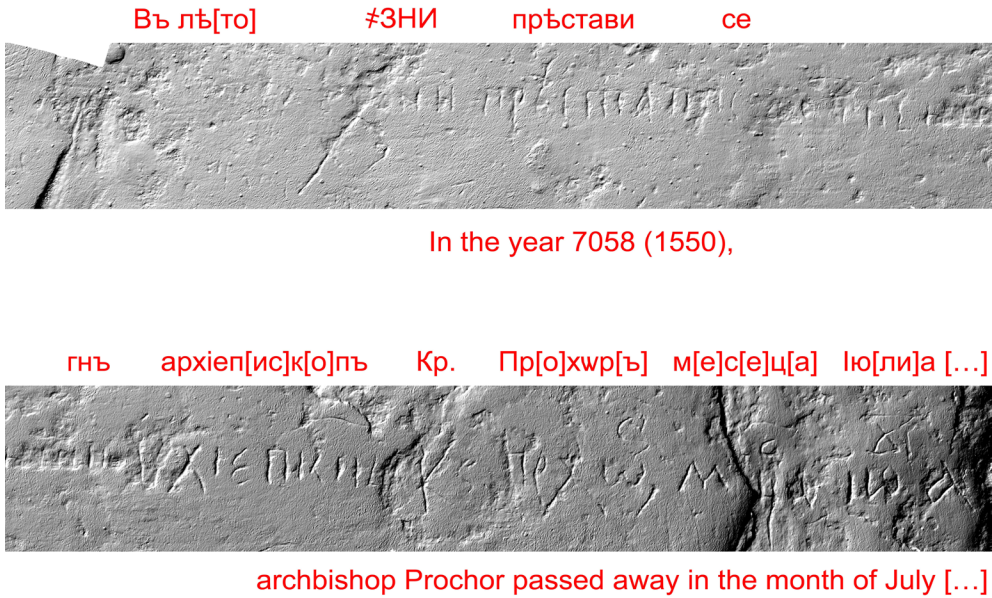
**Figure 15.** 3D model of the line of characters with higher resolution (3D point distance of 0.03 mm) cut in the middle and illuminated artificial raking light to ensure the characters can be read. Red: Cyrillic characters and English translation.

The content is thus clear in principle, but the exact reading remains to be checked, corrected and completed if necessary, as indicated by the bracketed parts. For example, such a formulaic inscription usually includes the date of death, which should appear at the very end. So far, there is no indication in the literature as to whether this number is still present or legible (Figures 14 and 15).
